SAFETY ALERT

ALERT DATE: 11-06-2020

WHAT: FALL/INJURY

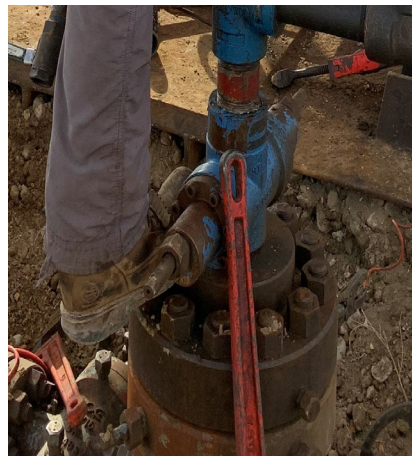
IP stepped up on flange and then onto the flow-line that is 3 feet off the ground and latched the rod elevator up to the two-foot pony sub on the top of the polish rod. IP stepped back down onto the flange and as he went to step his left foot to the ground, the IP's right foot got caught on the wellhead, causing him to fall backwards. He landed under the rod platform that was over 7 feet away, with his head and hard hat striking the cross support bar on the rod platform. The hard hat took the impact of the fall. The inside edge of the hard hat caused a laceration to the head.

Location of where IP's foot got caught on wellhead.

- Ensure proper footing when completing tasks.
- Utilize hoist or ladder when equipment is not designed for climbing access. Recommend use of winch and tag line for hoisting personnel to equipment. If hoist and tag line are unavailable utilize an approved ladder (ensure ground is stable for use of ladder).
- When hoisting personnel on winch line, stop all other non-safety sensitive operations in the immediate area.
- Practice Ladder Safety: ensure proper height and position close to work, face the ladder, keep both feet and one shoulder inside the rails while on the ladder, and maintain three points of contact; do not lean outside the center of gravity.

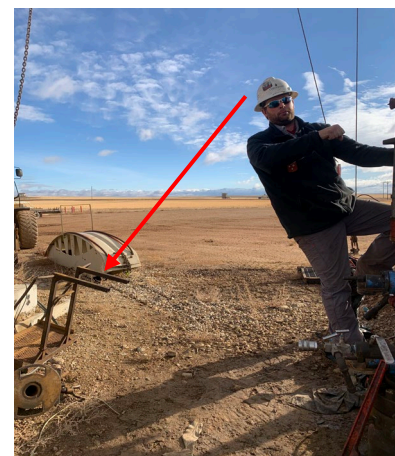
Distance between IP and rod stand.
